The Great Flood of 1993

Geologic Perspectives on the Flooding along the Mississippi River and Its Tributaries in Illinois

March 1994
Special Report 2

ILLINOIS STATE GEOLOGICAL SURVEY
Morris W. Leighton, Chief

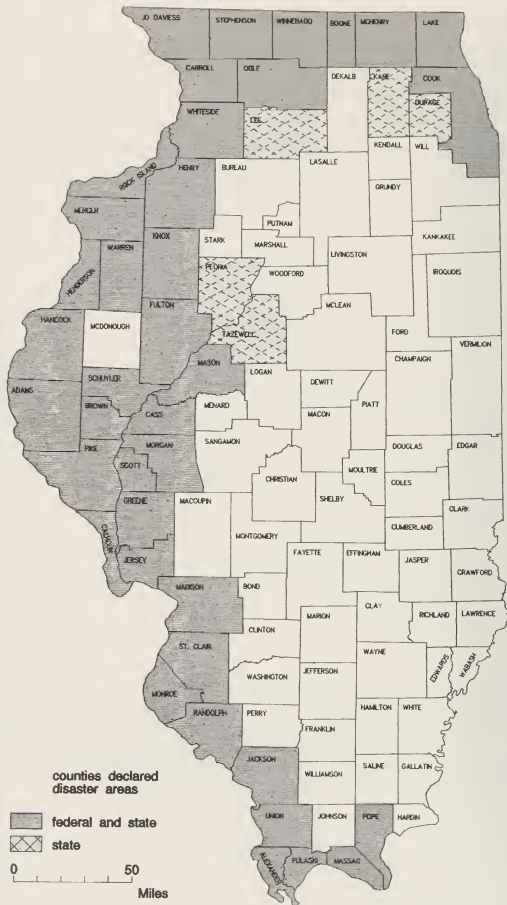
1 Illinois counties declared disaster areas at the federal and state level (39) and at the state level (5) as a result of the heavy precipitation and flooding during the summer of 1993. (Computer-generated map from the Illinois Geographic Information System; data from Illinois Emergency Management Agency.)

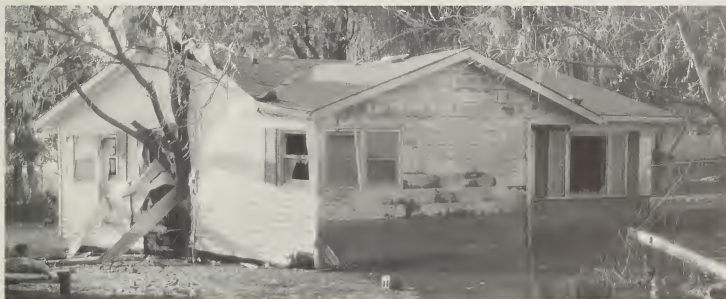
2 Monroe County: Flood water rushing through the town of Valmeyer lifted this house off its foundation and carried it until it collided with a tree (October 12, 1993).

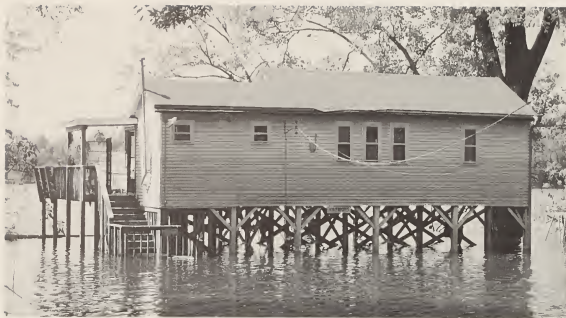
3 Adams County: High water came up to the windows of this house on stilts along the Mississippi River near Quincy. Oily film of silt and clay covers the lower half. Although the house stayed high and dry during other floods, it was not safe from the flooding in 1993, which exceeded the design height for flood protection (August 25, 1993).

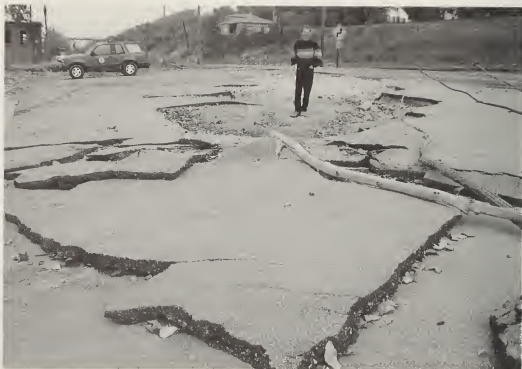
4 Randolph County: Asphalt pavement slabs next to the river-front road at Chester were lifted and transported by flood water. Robert Bauer, ISGS engineering geologist, stands where the blacktop slabs were eroded (October 13, 1993).

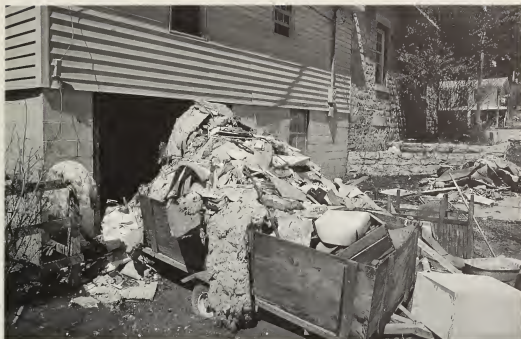
5 Jersey County: Aerial view (below) shows how much of Grafton was flooded at about the time of the highest flood crest (August 6, 1993). Water-saturated plasterboard and insulation removed from flood-damaged houses such as this Grafton home (left) cannot be reused. The debris from buildings affected by flood water will be a new burden on landfills. (September 3, 1993)

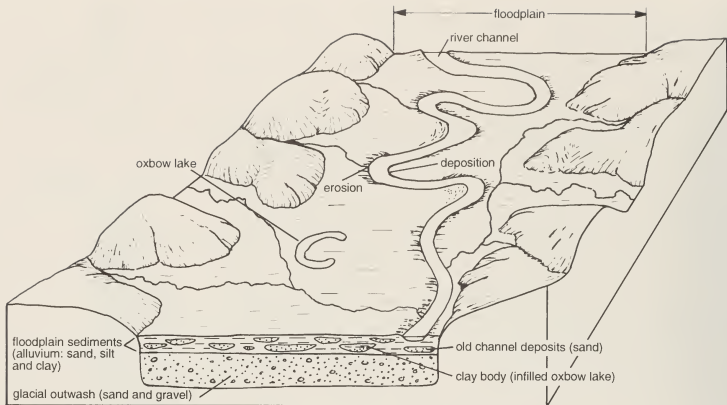
11 Major features of a well-developed floodplain in Illinois (adapted from Tarbuck and Lutgens 1976).

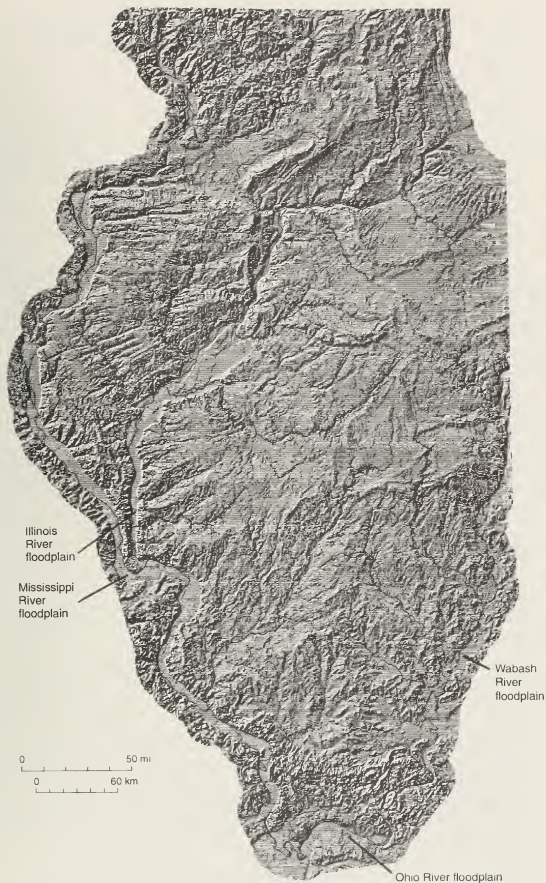
12 Shaded relief map of Illinois and parts of adjacent states. Nearly flat floodplains of the major rivers stand out in contrast to the variable relief of the uplands. (Computer-generated map from the Illinois Geographic Information System. Mapping derived from U.S. Geological Survey Digital Elevation Model data at 1:250,000 scale.)

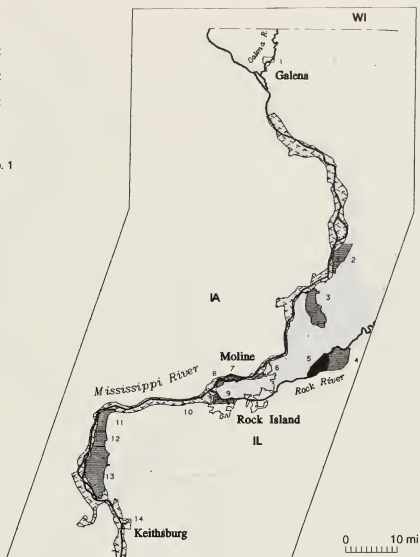
13 Floodplain and flood protection of the Illinois segment of the Mississippi River from the Illinois–Wisconsin state line southward to about 7 miles south of Keithsburg. (Figures 13–16: Computer-generated maps from the Illinois Geographic Information System [GIS]. Floodplain limits provided by the Illinois State Water Survey at scales 1:12,000 and 1:24,000. Flood inundation data, limited to Mississippi River valley, provided by the U.S. Geological Survey and the ISGS at 1:100,000 scale. Levee location data provided by the U.S. Army Corps of Engineers and the ISGS at 1:24,000 scale. Data on flooded levee districts from Illinois Department of Transportation Division of Water Resources and the U.S. Army Corps of Engineers.)

Figures 13 to 16 show the extent of floodplains along the Illinois segment of the Mississippi River and the Illinois River south of Peoria. These maps also show how widespread the flooding was (its maximum areal extent) in 1993. Also shown are locations and names of drainage and levee districts and other flood-protection systems, and the drainage and levee districts flooded in 1993. A subsequent section on sediment types and distribution discusses how levees are constructed and how they can fail.

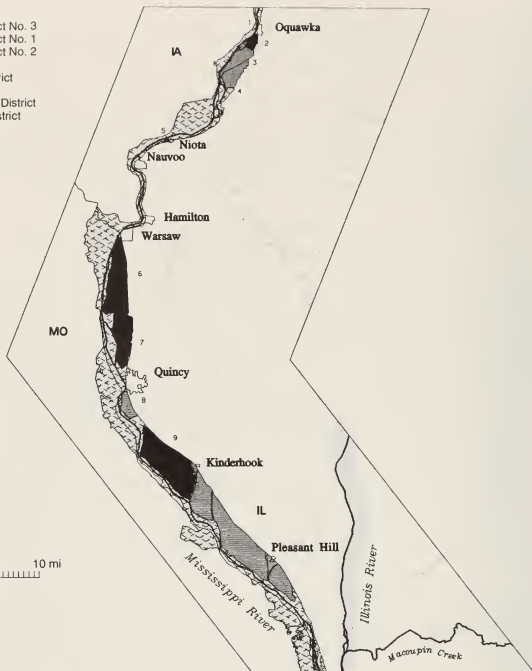
14 Floodplain and flood protection of the Illinois segment of the Mississippi River from about 4 miles north of Oquawka southward to about 25 miles south of Pleasant Hill.

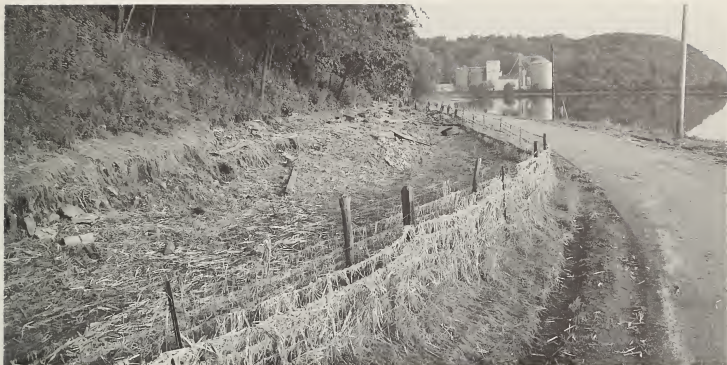
17 Greene County: Dead vegetation (above) commonly marks high water line, as in this view of the Illinois river valley within the Hillview Drainage and Levee District. The town of Hillview is in the distance. Note the abundance of corn plant debris caught in the barbed-wire fence (August 25, 1993). Topographic map of Hillview and vicinity (left) shows configuration of the high water line. Spacing between contours relates to land slope. The widely spaced contours represent the relatively flat land of the floodplain. Closely spaced contours are the steep slopes of uplands and bluffs. Base map, Pearl East Quadrangle, USGS 7.5-minute topographic map, 1980.

In any particular area along the flood margin, the surface elevation of flood water was uniform and defined a curving line of uniform elevation on the land surface (like the contours on a topographic map; fig. 17). As flood water receded, the high water line was well marked by the upper limit of dead vegetation, something like the ring left in a bathtub after the water drains out. Figure 17 shows the high water mark on a hillslope along the margin of the Illinois River valley. The extremely high water levels in this area caused flooding above the limits of the floodplain and up onto a bluff slope. The valleys and floodplains of tributary streams draining the uplands were low areas where flooding could extend even farther from the main river channel. The high water line in figure 17 goes around the hillslope and into the distant valley.

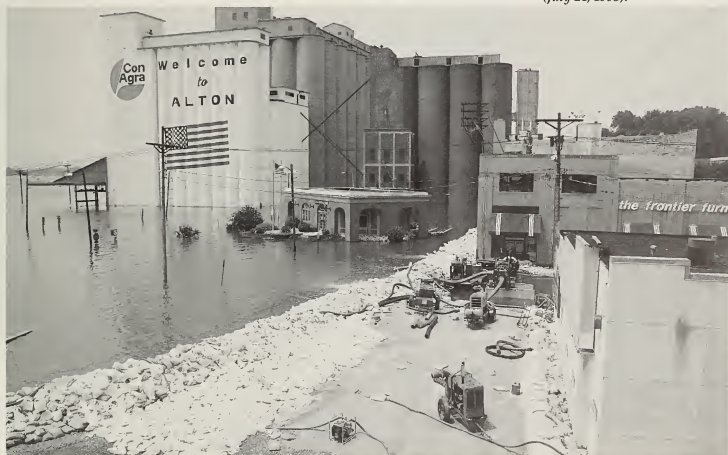
20 Madison County: Looking west along the sandbag dike used to prevent inundation of the valley in the west part of downtown Alton. Water from backed-up sewers and underground steam pipes along Piassa Street was pumped to the river (July 24, 1993).

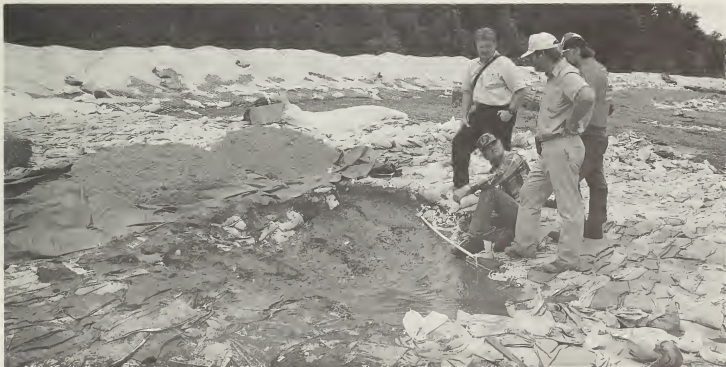
24 Pike County: Water seepage caused piping of sandy material in the Sny Island levee, at about the place where it failed on July 25, near East Hannibal. The observers are engineers from the U.S. Army Corps and officials of the Sny Island Drainage and Levee District (July 21, 1993).

Flood water on the river side of levees applies pressure to the levees, which are constructed to hold back water for a short time. Because of the unusually long duration of high water in the flood of 1993, water infiltrated permeable layers within and beneath the levees. The result was seeps piping sand out of the levee on exposed levee slopes. Along much of the Sny Island levee bordering the Mississippi River south of Quincy, seeps were a widespread problem, causing the levee to fail on July 25 (fig. 24).

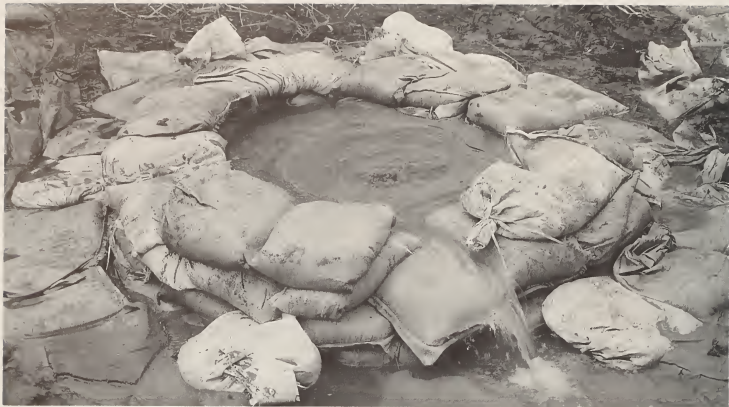
25 *Pike County: Sand boil at the foot of the Sny Island levee. Sandbag ring dike prevents loss of piped sand but lets water flow away, reducing water pressure under the levee (July 21, 1993).*

Sand boils were common on the floodplain adjacent to many levees. They formed where lenses of sand under or within a levee provided a pathway for water to pipe sediment. Unless piping (erosion) of sediment under or within the levee was halted, the flowing water would quickly sap the levee structure and cause a catastrophic failure. Sand boils were counteracted by building a dike of sandbags around the boil (fig. 25) and allowing water to rise within the ring. The rate of flowing water slowed within the ring dike, and the sandbags minimized the loss of sediment by trapping it in place and equalizing water pressure. Allowing the water to flow over the sandbag dike prevented water pressure from building up elsewhere in the levee. Sand boils can develop, then cease activity as changes occur in the flow pathways within the levee. Fine grained materials (silt or clay) transported within the levee may block the flow path and shut off one sand boil while opening a channel for another (fig. 26).

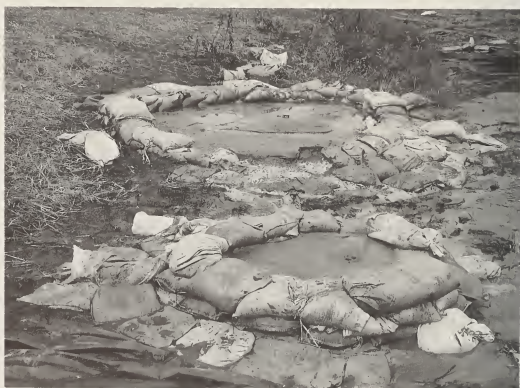
26 *Active and inactive sand boils side by side at the foot of the Sny Island levee. Flow paths to the inactive boil (top) were possibly shut off by internal shifting of sediments (July 21, 1993).*

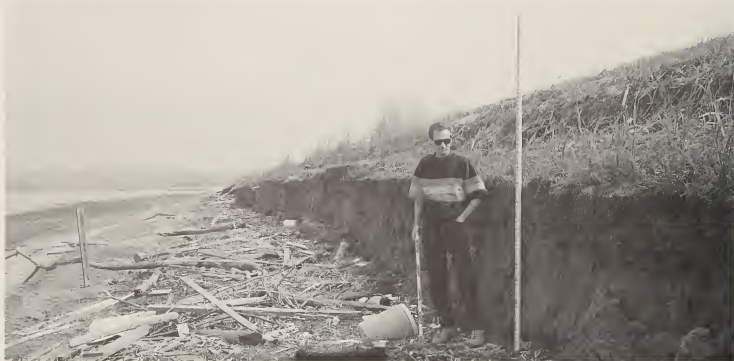
28 Randolph County: Nearly vertical cut made by waves eroding the inner (landward) side of the southern part of the Kaskaskia Island levee. Note the driftwood and debris where IGS engineering geologist, Robert Bauer, stands at the base of the erosional cut (October 13, 1993).

In some areas, flood water of the Mississippi and Illinois Rivers submerged the floodplain from bluff to bluff. As a result, temporary lakes formed that were several miles wide (see cover photo). Waves on these lakes eroded the land along the high water lines. In many places, a wave-cut notch ranging from a few inches to 1 foot high was eroded along the high water line. Along bluff slopes, the erosion caused the soils overlying the notch to slump and undermined the foundation of trees and shrubs. Some farmers may face considerable expense in leveling their fields, but in general, the wave erosion had no major consequence. Remedial action will be required, however, along the inner side of the Kaskaskia Island levee, where an erosional cut nearly 5 feet high was formed by severe wave action (fig. 28). Apparently, the abundance of sandy materials in this section of the levee accelerated the wave erosion.

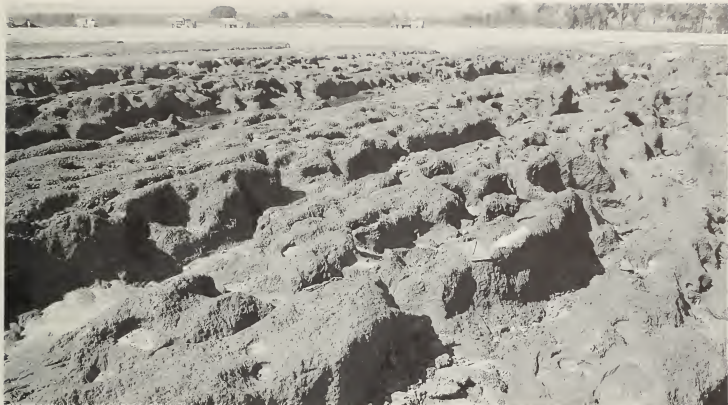
29 Monroe County; Deep erosion in the floodplain near a levee breach (October 12, 1993). The erosional scars may follow old plow furrows; the cuts are about 1 to 2 feet deep. Note pen atop field notebook (arrow) for scale.

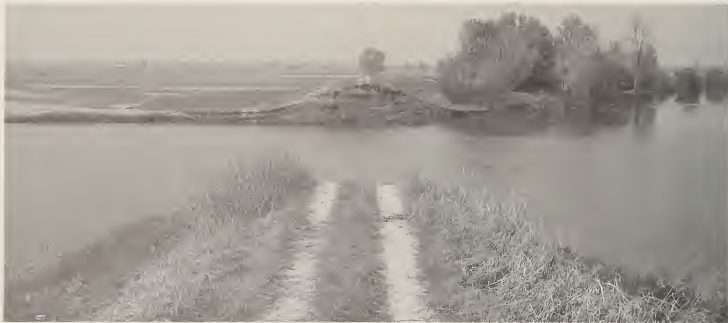
30 Randolph County: Looking northward across the levee breach in the Kaskaskia Island levee. (Figure 31 shows the depth of scour through this breach.) The Mississippi River channel is to the right beyond the range of the photo. (October 13, 1993).

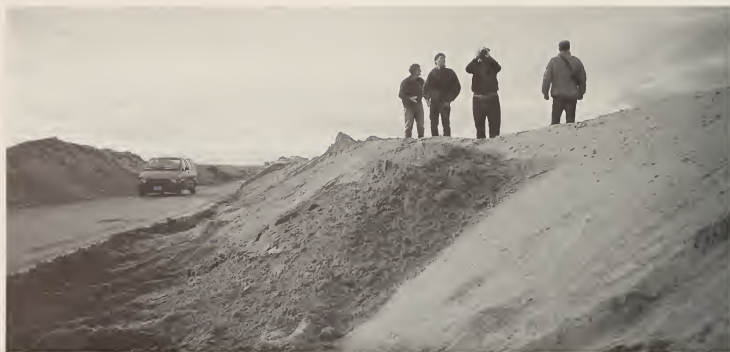
36 *Monroe County: Near the Columbia levee breach, the road cuts through sand 3–6 feet thick, deposited like a large sandbar or river dune commonly found along the bottom of river channels. ISGS geologists head for their minivan after a close look at the dune-like sand that buries fertile farmland (November 23, 1993).*

This sand deposit looks like a snowdrift (fig. 35) or a desert landscape (fig. 36). Its thickness varies, but a maximum of 8 feet was measured. A band of deposition, about 1,500 to 2,500 feet beyond the levee breach, ranges from about 3 to 7 feet thick; it is essentially a large bar or river dune such as that commonly found along the bottom of river channels.
